Analysis of Cold In-place Recycled Asphalt Pavements

A research study by Organizational Results in cooperation with the Northwest District and the Maintenance Division

MoDOT Summary Statement

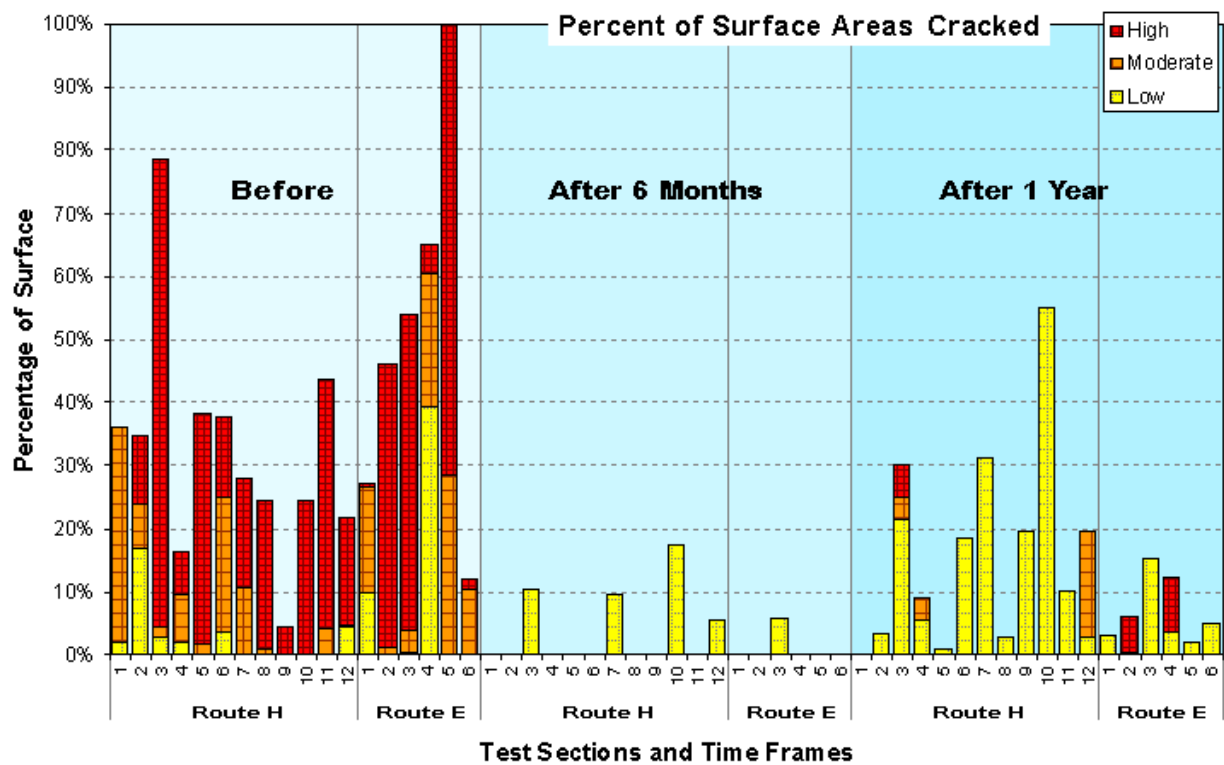
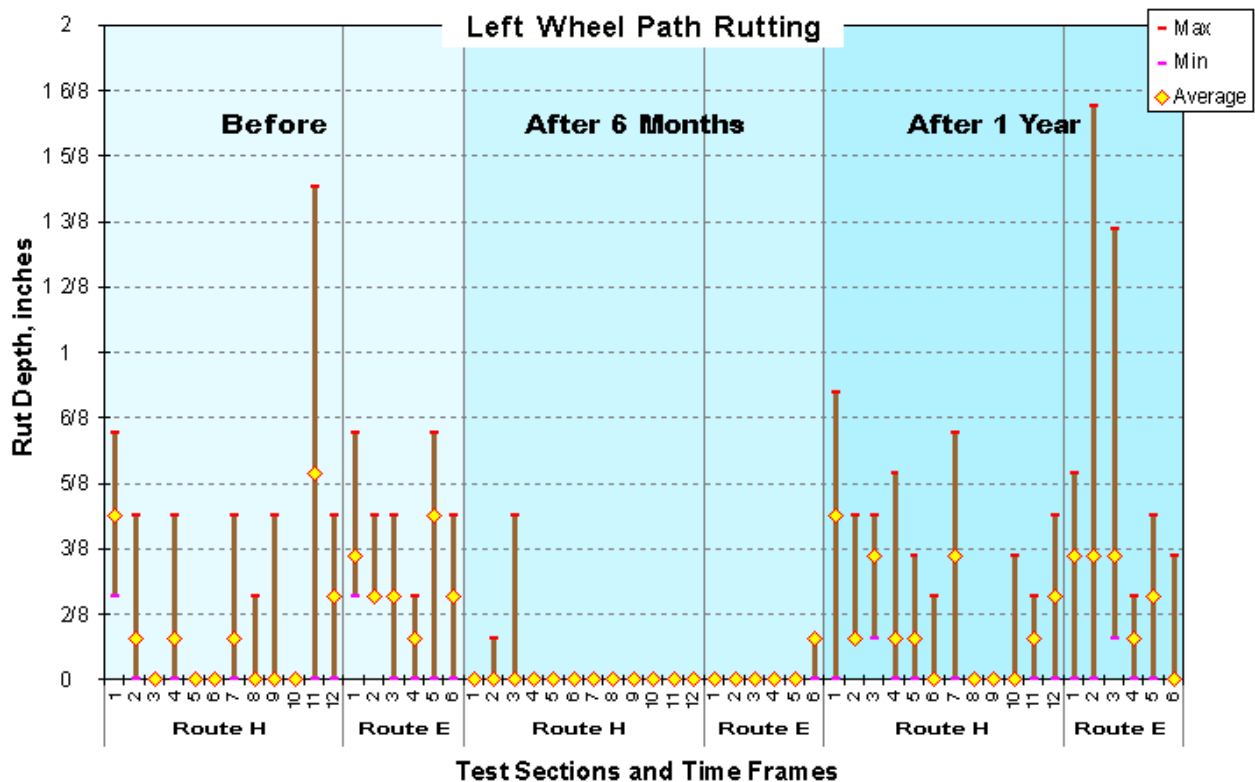
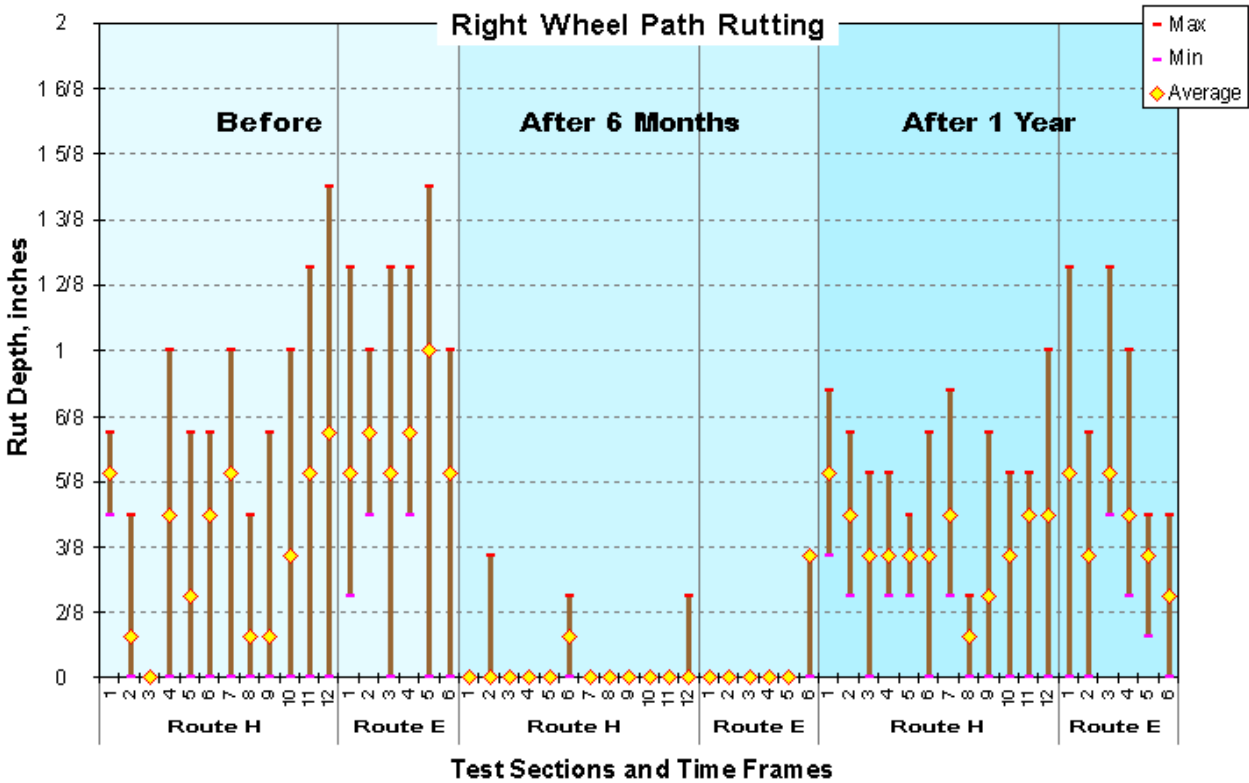
The CIR project in Gentry Co. has been open to the traffic for more than one year. Immediately after construction, the comments from the traveling public were quite favorable. However, within five weeks after the routes were opened to traffic, the first of many failures in the road surface began to appear. Areas of fatigue cracking were first noticed before the surface began to break up and the underlying subgrade worked its way to the surface. The subgrade turned out to be wet clay.

The rutting and fatigue cracking that was so prevalent throughout the test sections prior to construction were eliminated with the CIR placement. After 6 months of service, there was no evidence of rutting in any of the test sections and only a small amount of low severity fatigue cracking was found. Rutting in the test sections did appear during the one-year survey and was

almost identical to the severity that was recorded prior to construction. The fatigue cracking wasn't as severe as it was prior to construction, but the areas of fatigue cracking did increase dramatically when compared to the six-month visual distress survey.

As the patching and repairs became more frequent during the summer months, it was decided that a 1-1/4" hot mix overlay should be placed on the CIR. The overlay was placed in October 2009.
